**DOMINION VOTING SYSTEMS
InterScan 821D HiPro Scanner
Modification to DemSuite 5.2
Administrative Approval Report**

**Components:
InterScan 821D HiPro Scanner,
Dell OptiPlex 7040 Workstation,
ImageCast Central Version 5.2.2.7**

**Staff Administrative Approval Report
Prepared by:
Secretary of State's Office of
Voting Systems Technology Assessment
May 8, 2018**

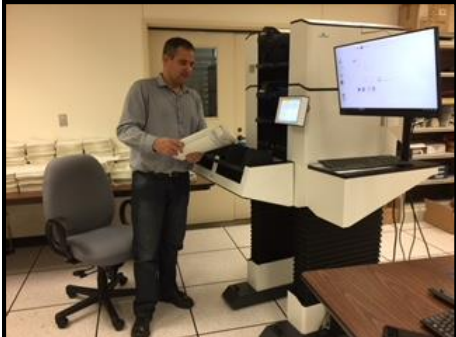
The Interscan 821D HiPro scanner, while not a voter usable device, includes the ability to lower and raise in order to accommodate an elections office worker.

It was found that the Interscan 821D HiPro scanner is easily adaptable for sitting or standing elections workers. It was determined that the technologies implemented for accessibility and usability in the Interscan 821D HiPro scanner improved the experience for election workers that may be required to spend hours at a time operating the Interscan 821D HiPro scanner.
